Historic Road Bridges

Fingal County Council

Volume 2
Built Heritage &
Ecological Inventory of Bridges

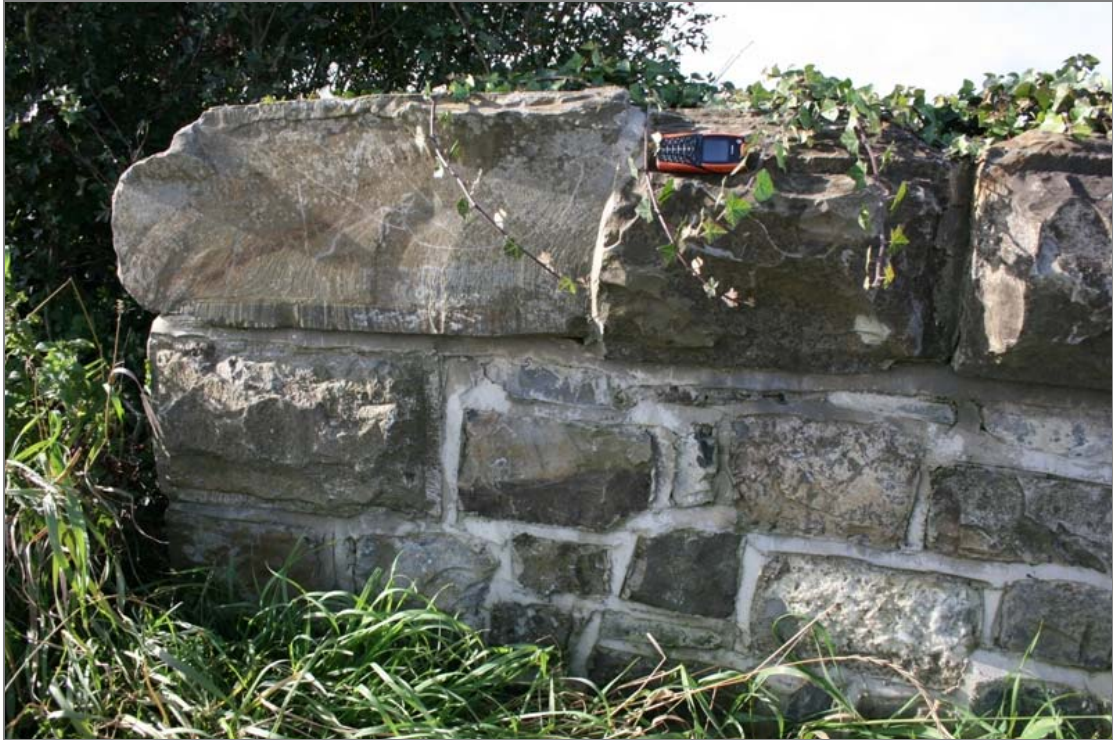
FHBS-03-BH-05 ~ Repaired west parapet

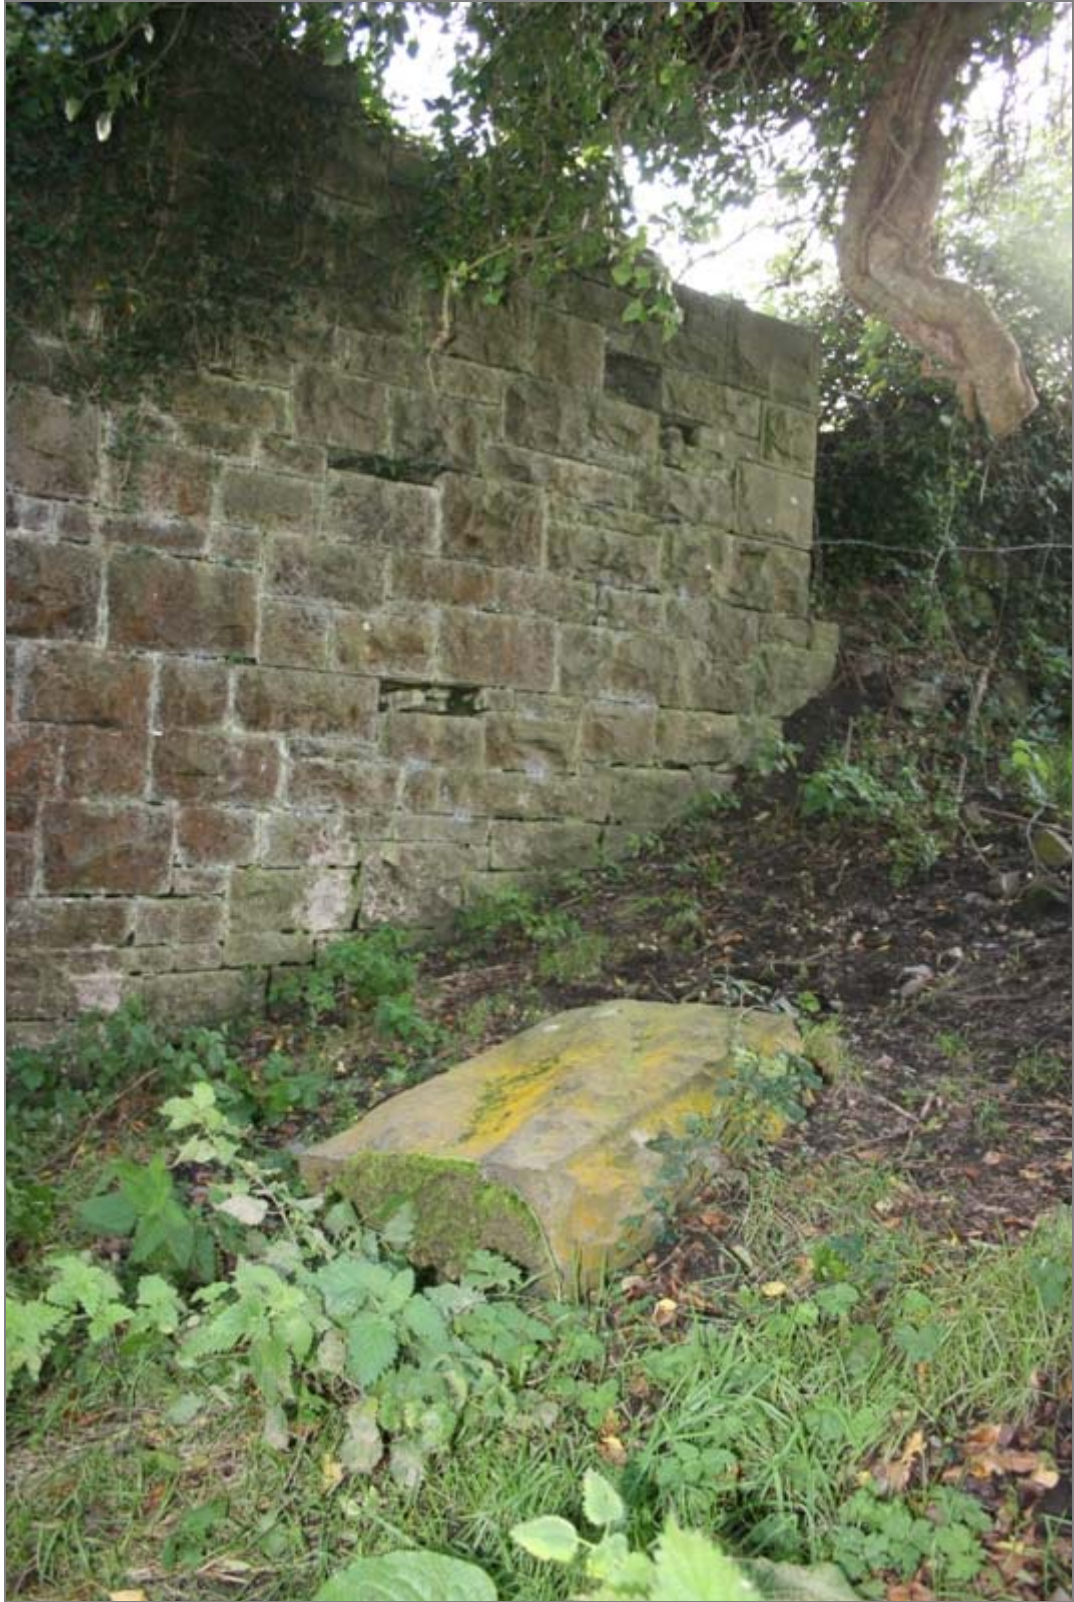
FHBS-04-BH-06 ~ Dislodged coping stone and stones missing from south abutment on west elevation.

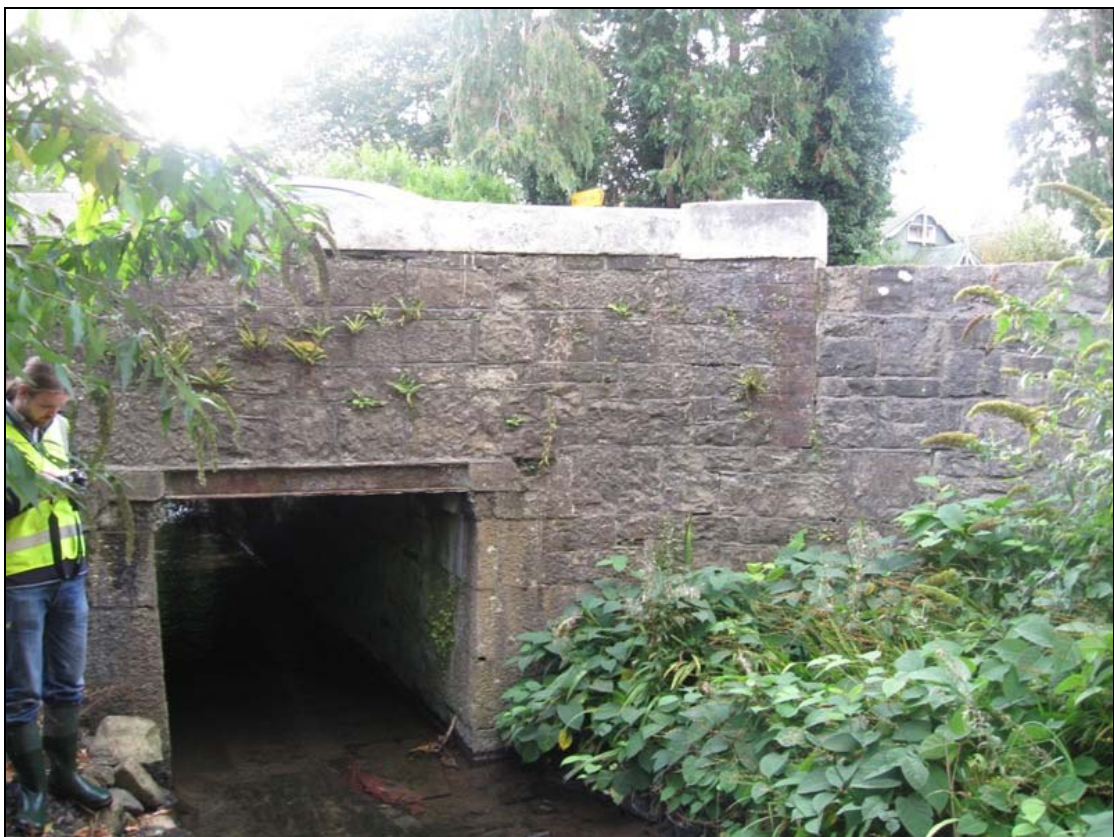
FHBS-05-NH-04 ~ Japanese knotweed downstream of bridge structure

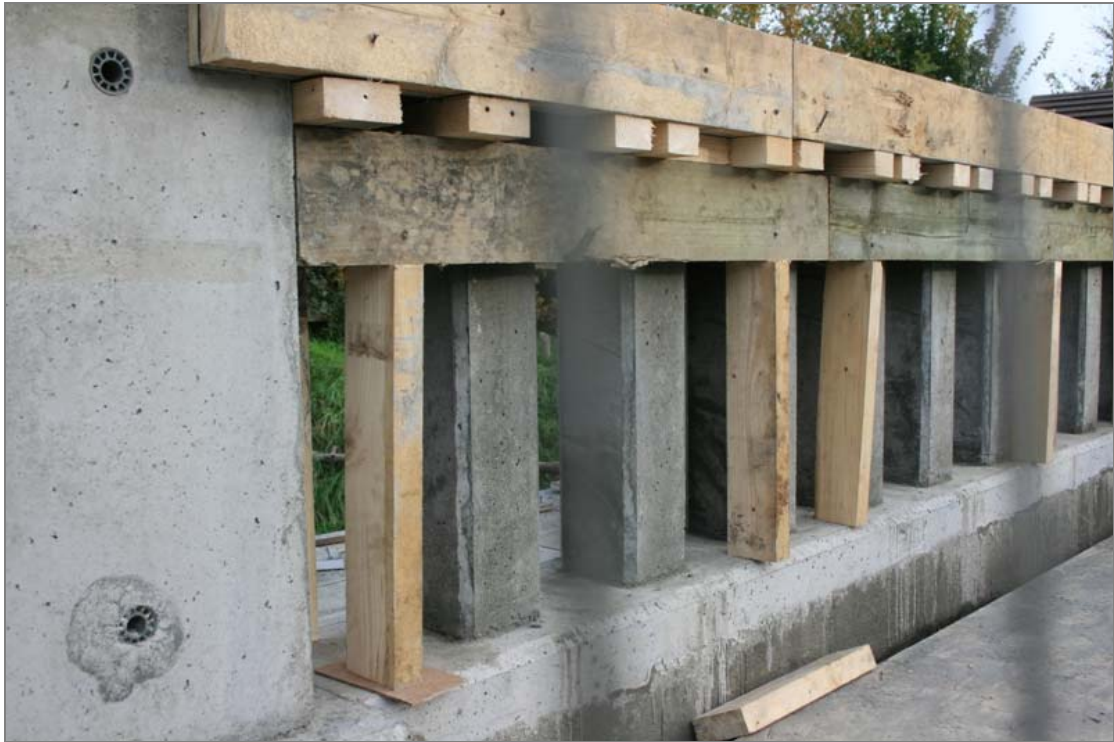
FHBS-06-BH-06 ~ Replacement, reinforced cast concrete balusters to east parapet.

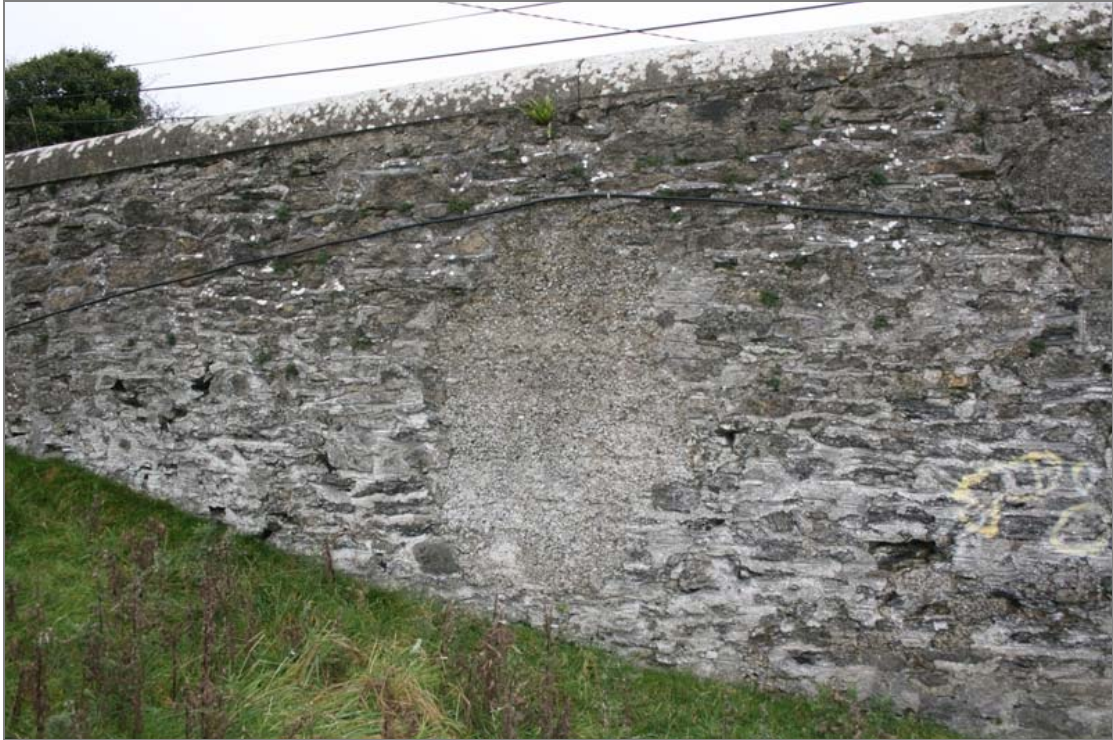
FHBS-07-BH-05 ~ Cast concrete repair on bulging section of southern abutment on eastern side of bridge

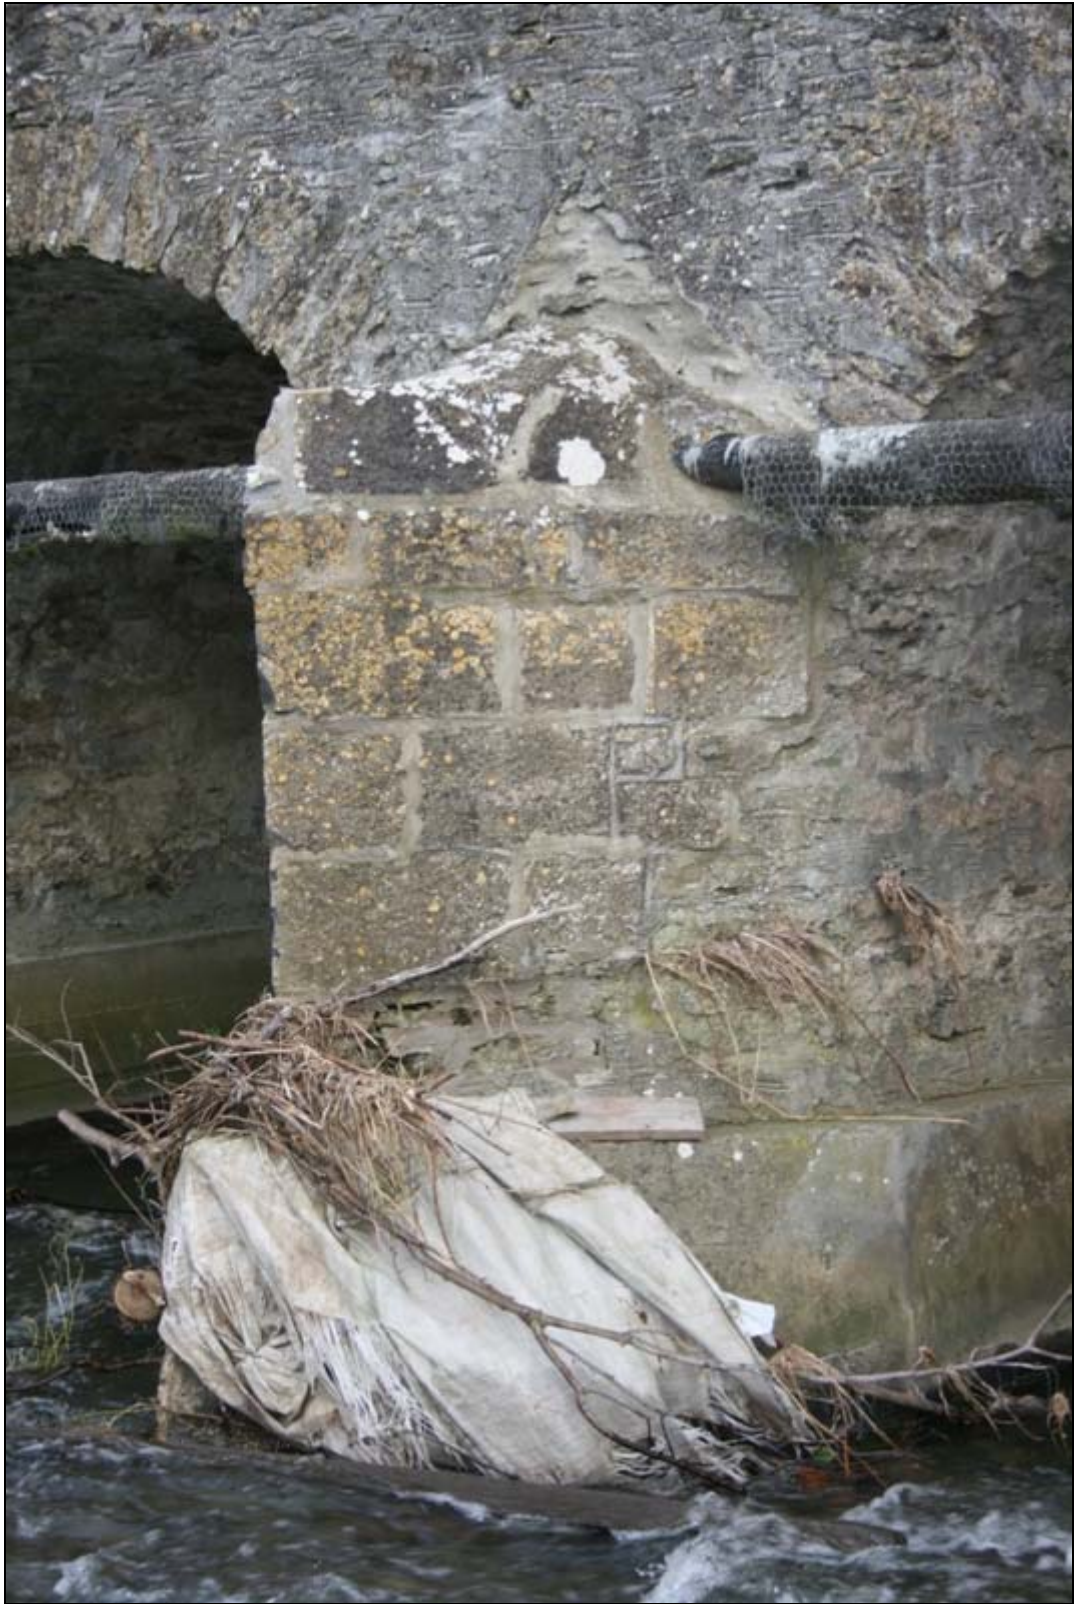
FHBS-08-BH-05 ~ Re-built stone cap of western cutwater

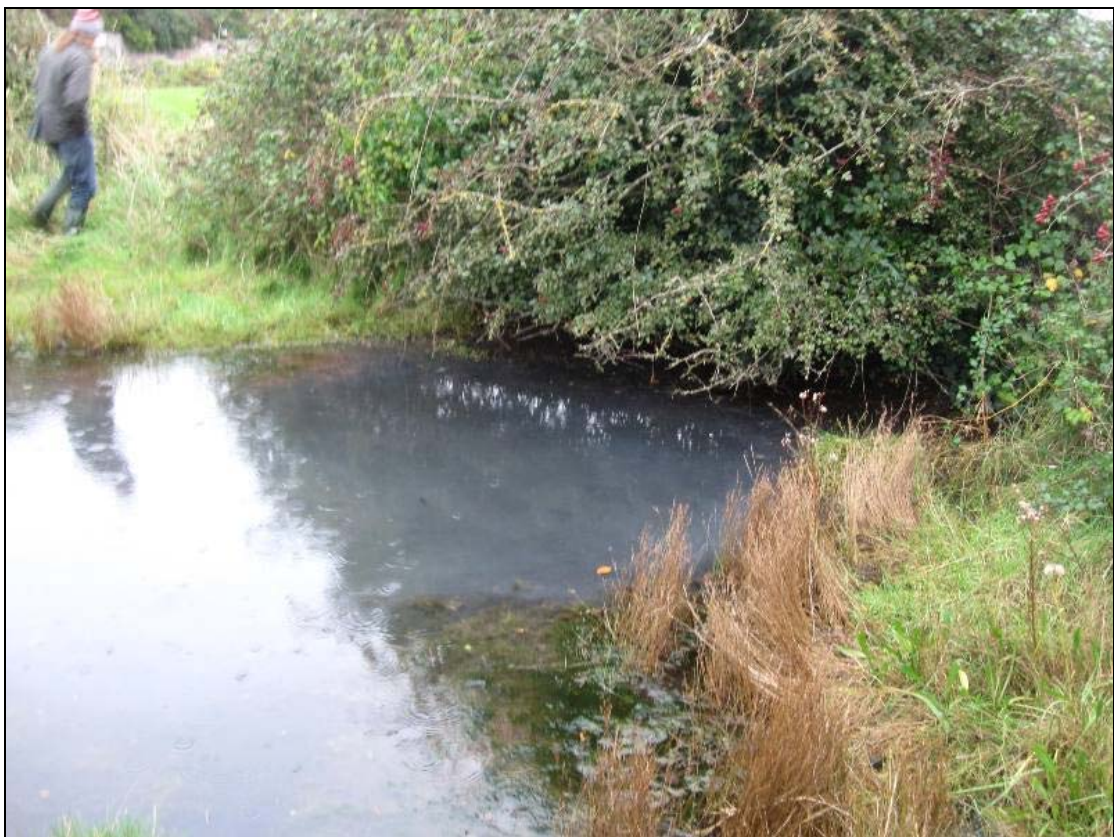
FHBS -10-NH-06 ~ Stream eutrophication from nearby septic tank/ seepage area

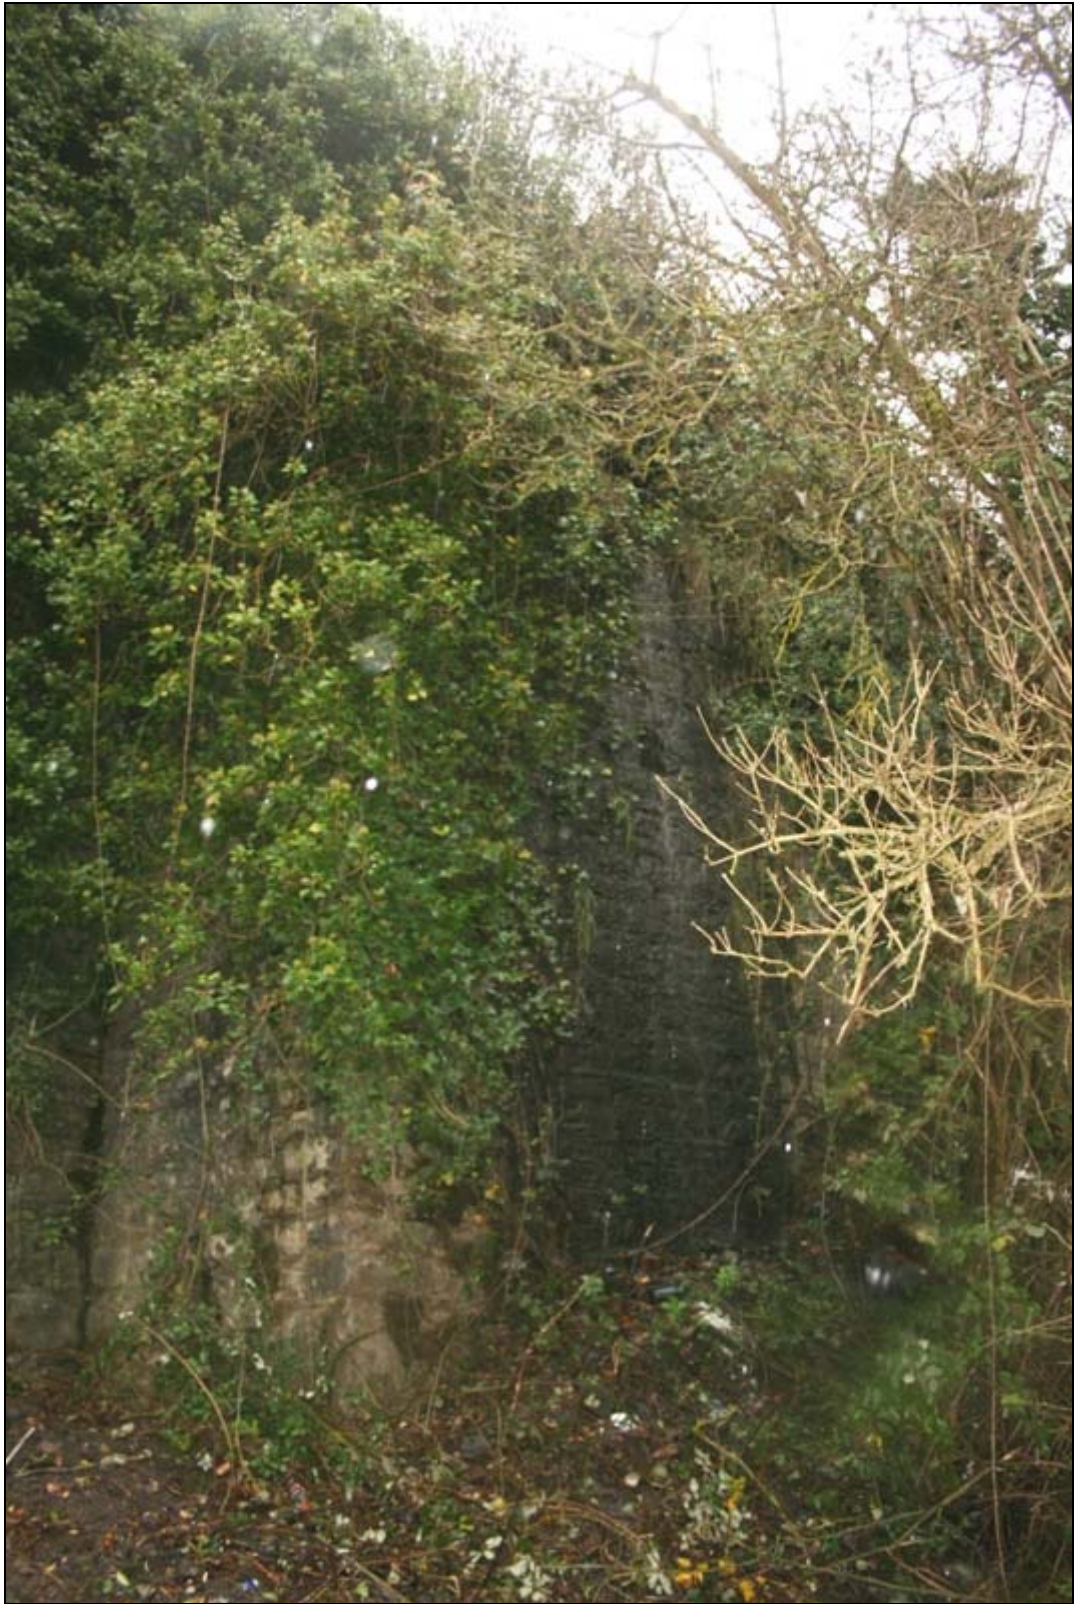
FHBS-11-BH-04 ~ North east buttress with road drainage washing over and vegetation rooted in masonry

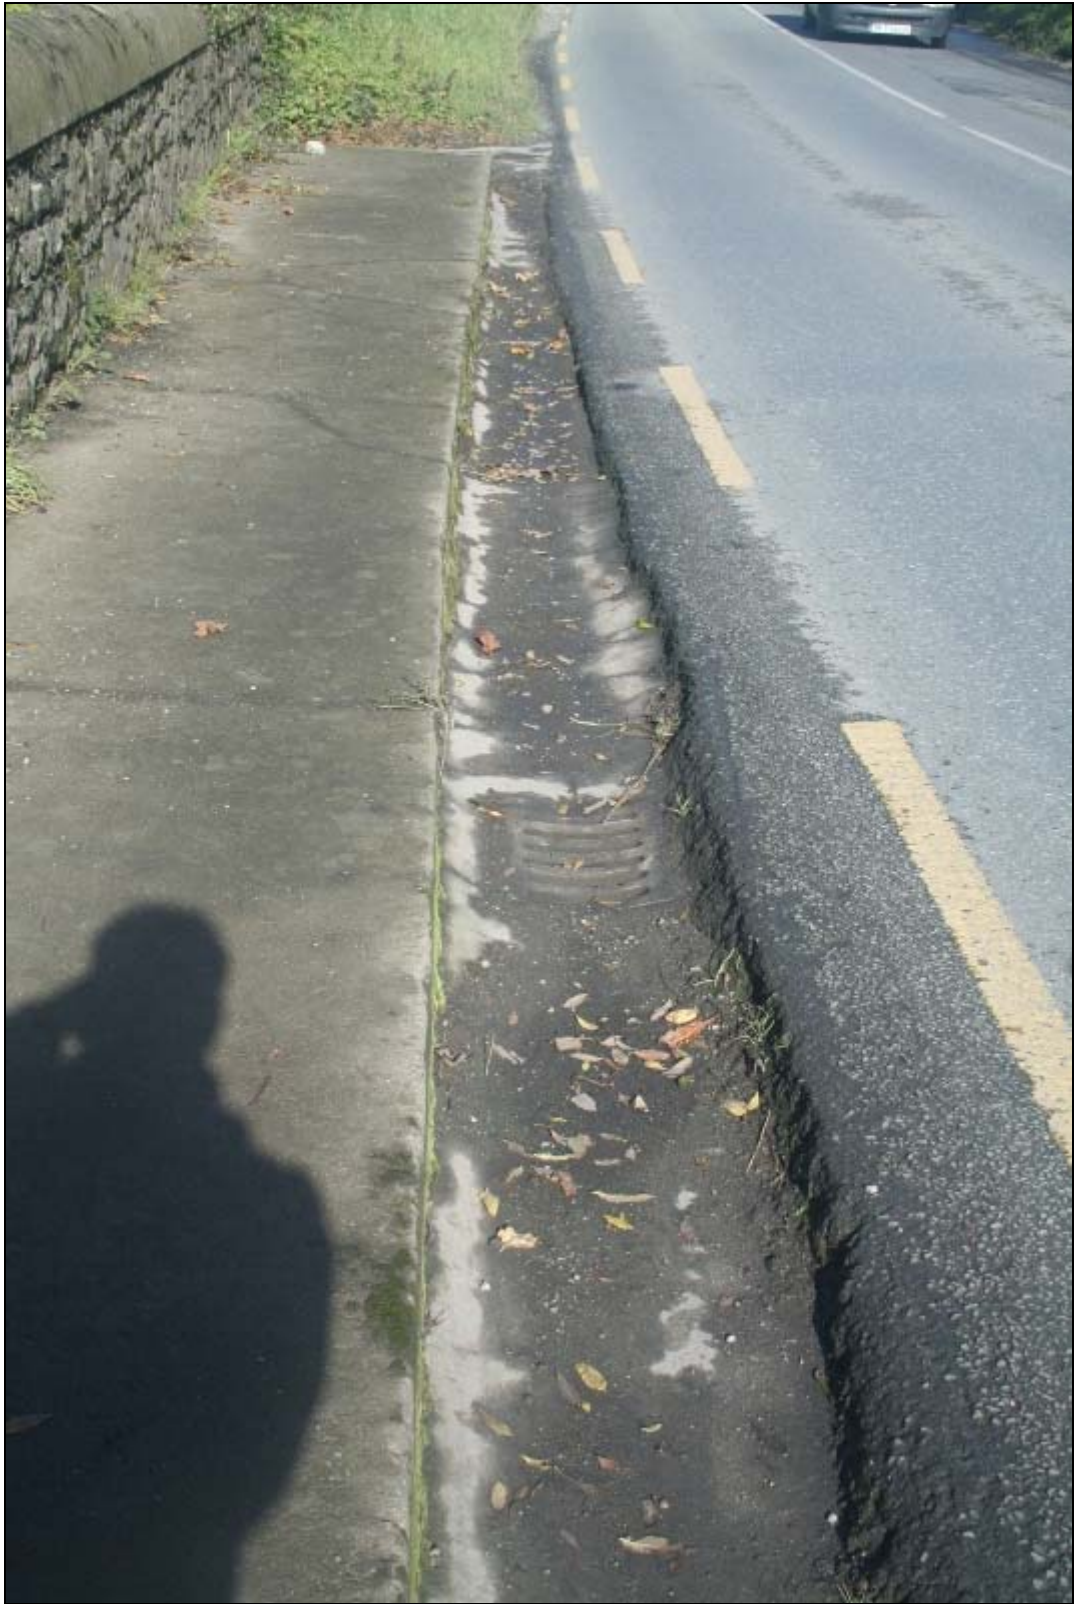
FHBS-11-BH-07 ~ Detail of road drainage beside footpath on west parapet

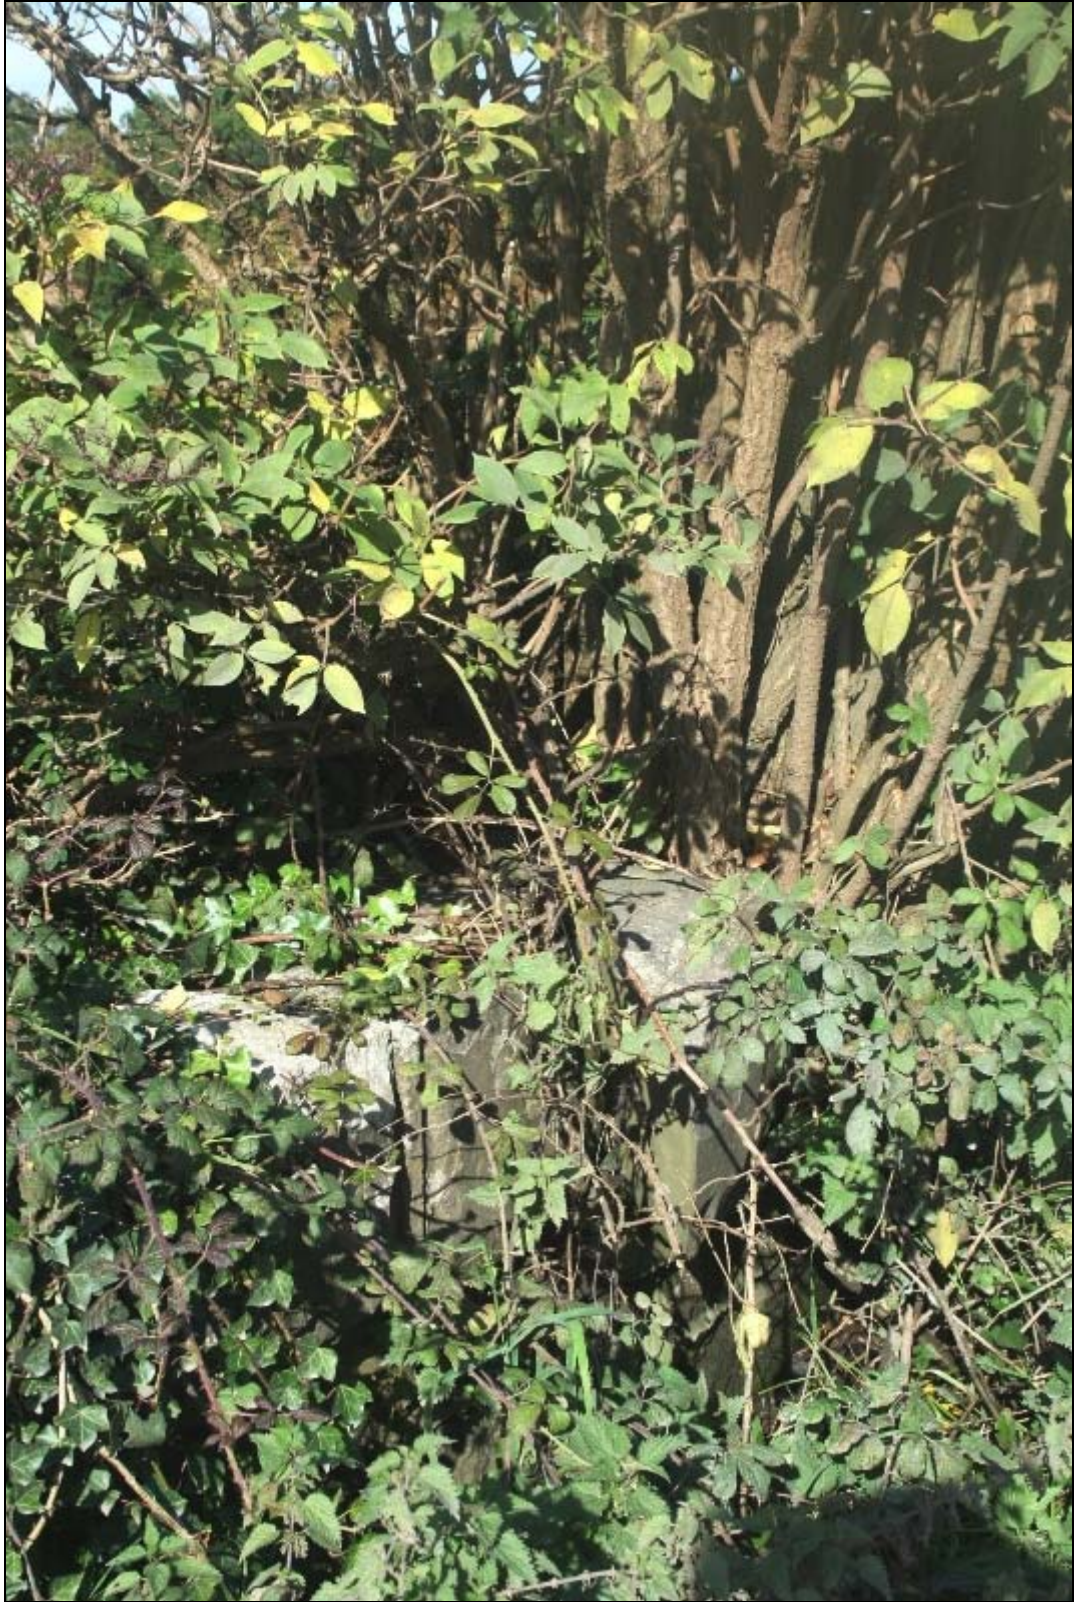
FHBS-12-BH-05 ~ Tree rooted on west parapet and dislodging stones

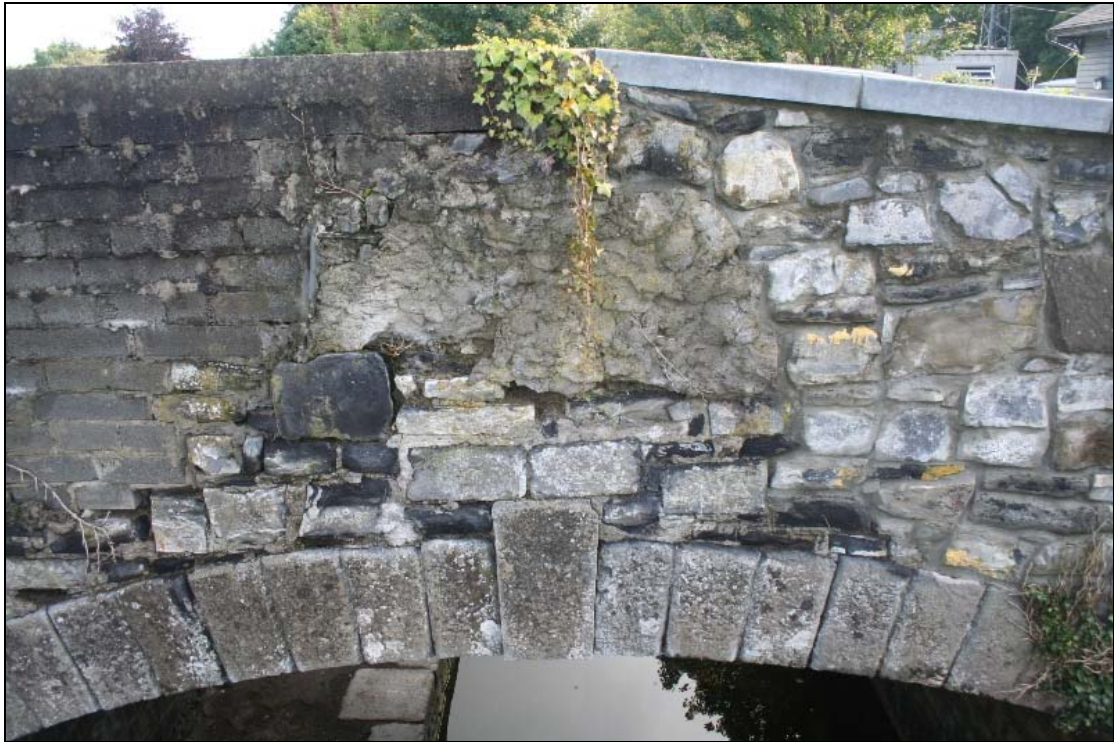
FHBS-14-BH-05 ~ Apex of west elevation showing variety of repair materials

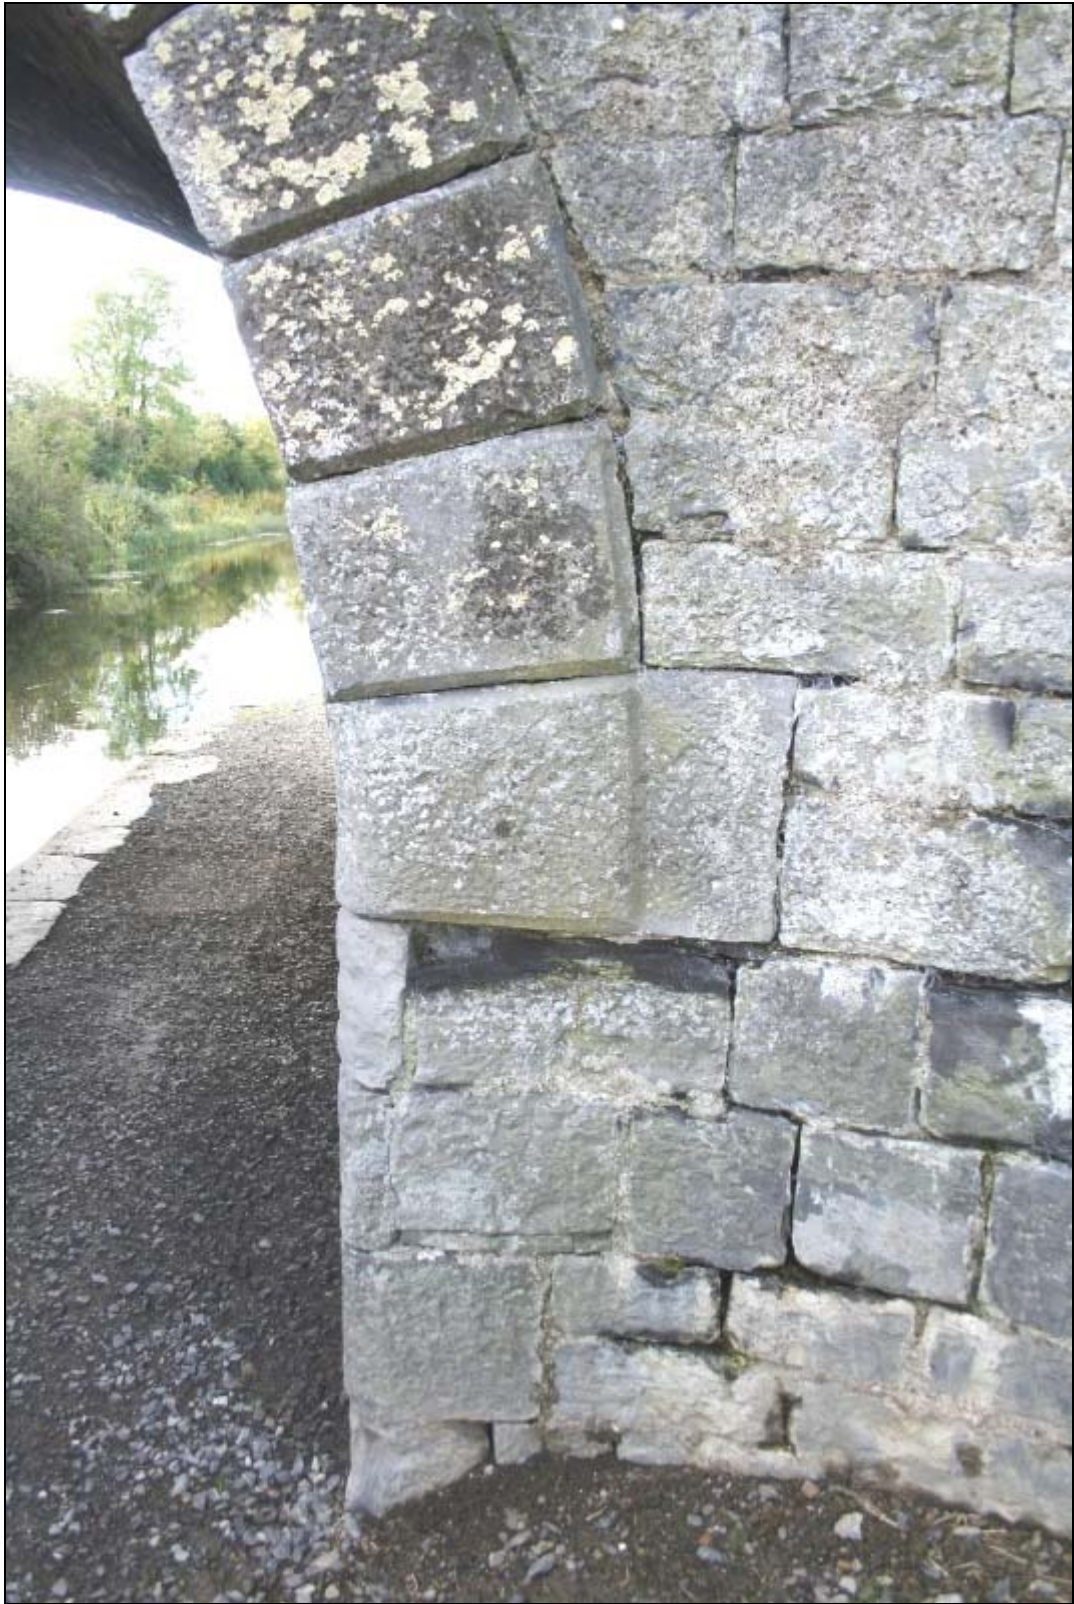
FHBS-15-BH-06 ~ Remains of lime render on north abutment of east side of canal bridge
